New Airtex Improved Connector and Pigtail for GM Fuel Pump Modules

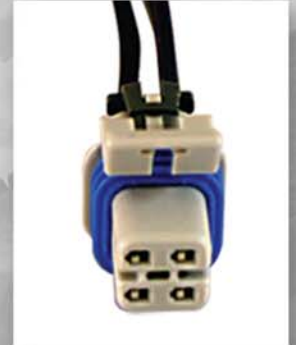
OLD VEHICLE HARNESS
SOLD SEPARATELY

Many GM vehicles from 1988 to 2005 have electrical connectors on the fuel pump module that may become loose over time due to vibration, leading to faulty, high-resistance connections. The symptoms - burned or melted connectors and pins - lead to a voltage drop situation where low or no voltage can cause the module to stop pumping.

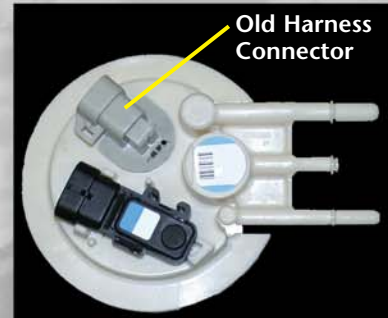
OLD DESIGN-TOP & SIDE VIEW

GM FUEL PUMP MODULE WITH OLD HARNESS CONNECTOR

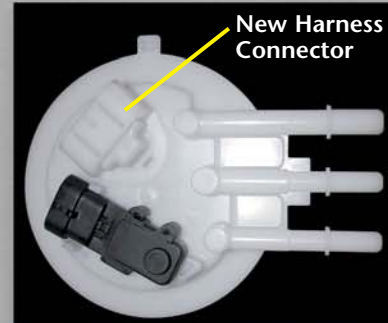
NEW DESIGN-TOP & SIDE VIEW

GM FUEL PUMP MODULE WITH NEW HARNESS CONNECTOR

New wiring harness included.
Refer to enclosed installation instructions.
