New Airtex Improved Connector and Pigtail for GM Fuel Pump Modules

The Problem

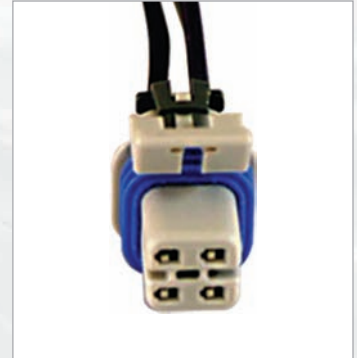
Old Vehicle Harness
Sold Separately

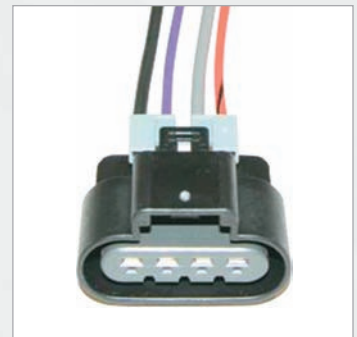
New Vehicle Harness Included
with Fuel Pump Modules

Fuel pump modules with the improved 4-pin connector require vehicle harness replacement. One of the five application-specific, color-coded vehicle wiring harnesses is included with every pump that uses the new connector.

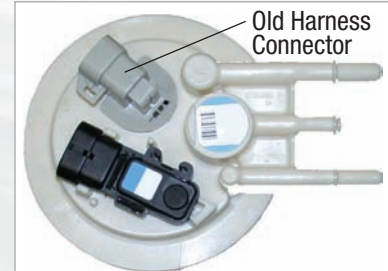
Old Design—Top & Side View

Many GM vehicles from 1988 to 2005 have electrical connectors on the fuel pump module that may become loose over time due to vibration, leading to faulty, high-resistance connections. The symptoms – burned or melted connectors and pins – lead to a voltage drop situation where low or no voltage can cause the module to stop pumping.

GM Fuel Pump Module with Old Harness Connector

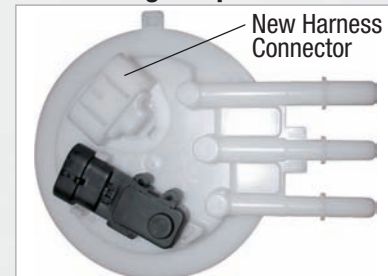
New Design—Top & Side View

GM Fuel Pump Module with New Harness Connector

Airtex Products' latest fuel system solution provides a quick and reliable fix for burned or melted wiring harness connections on certain GM in-tank fuel pump applications. Airtex has replaced the faulty OEM design connector with a new OEM design that eliminates the burned or melted connectors and pins problem.
